Manhole Inspection Summary

Manhole # S41II_041MH

Location Address: **1508 HARFORD AVE**

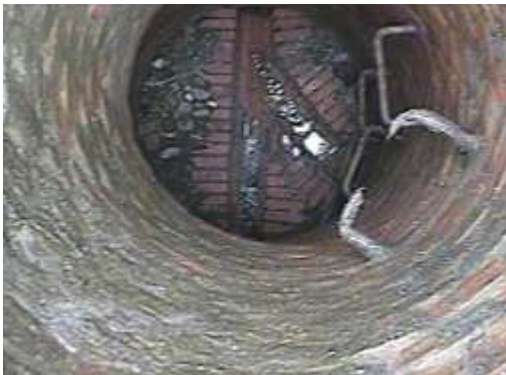
Defect 2

Count: **6** Missing: **2** ☒ **Corroded**

STEPS CORRODED

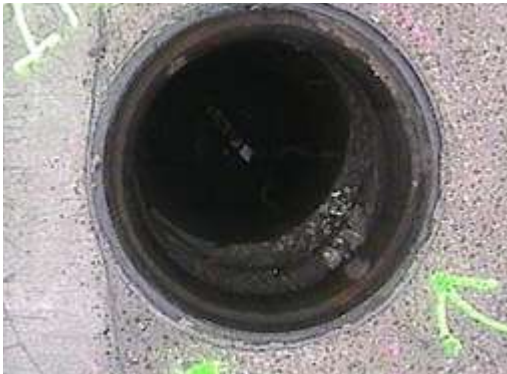
Defect 1

Offset: **6** (in.)

FRAME OFFSET

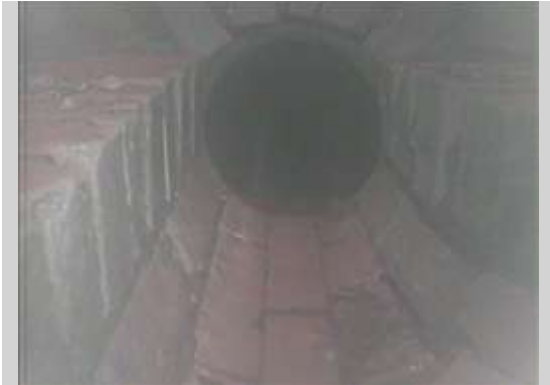
12 O'Clock Outflow

Pipe Height: (in.) Direct
Pipe Material: **Clay** ☐ Pipe Lined
Invert Depth: **11.15** (ft.) Flow Characteristics: **Slow**
Deposits: ☒ None ☐ Mud ☐ Sludge ☐ Debris ☐ Grease
Silt Depth: (in.) Deposits Extent:
Infiltration: **None** Pipe Seal Cond: **Sound**

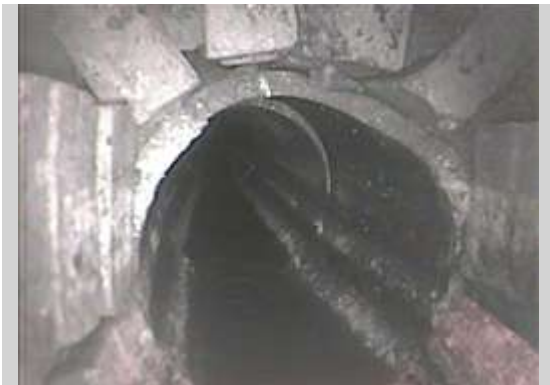
4 O'Clock Inflow

PIPE SEAL CRACKED.

Pipe Height: (in.) Direct
Pipe Material: **Clay** ☐ Pipe Lined
Invert Depth: **11.20** (ft.) Flow Characteristics: **Slow**
Deposits: ☒ None ☐ Mud ☐ Sludge ☐ Debris ☐ Grease
Silt Depth: (in.) Deposits Extent:
Infiltration: **None** Pipe Seal Cond: **Cracked**

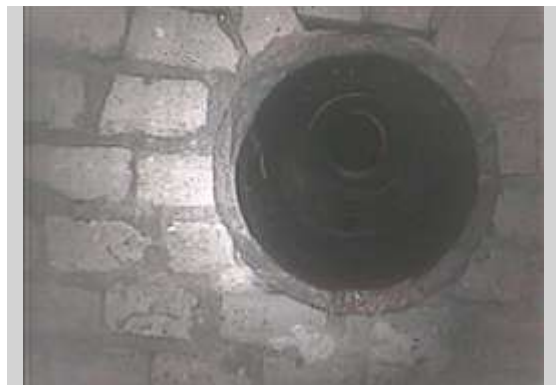
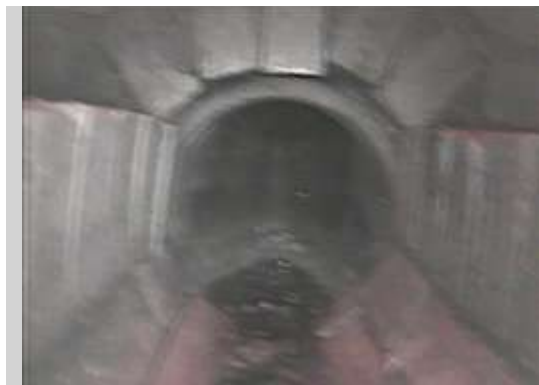
6 O'Clock Inflow

Infiltration: **None** Pipe Seal Cond: **Sound**

Drop: **Outside** **Direct**

Drop Condition: **Open**
